NEW JERSEY STATE DEPT OF ENVIRONMENTAL PROTECTION TRENTON F/G 13/2
NATIONAL DAM SAFETY PROGRAM. WAGAMONS POND (DE00061), DELAWARE --ETC(U)
MAR 79 T T MOORE

REPORT DOCUMENTATION PAGE		READ INSTRUCTIONS BEFORE COMPLETING FORM
1. REPORT NUMBER DE00061	2. GOVT ACCESSION NO.	3. RECIPIENT'S CATALOG NUMBER
4. TITLE (and Subtitle) Phase I Inspection Report National Dam Safety Program Wagamons Pond Dam Sussex County, N.J.	5. TYPE OF REPORT & PERIOD COVERED 9 FINAL rept.

OVERALL VIEW
OF
DAM

NAME OF DAM: WAGAMONS POND DAM

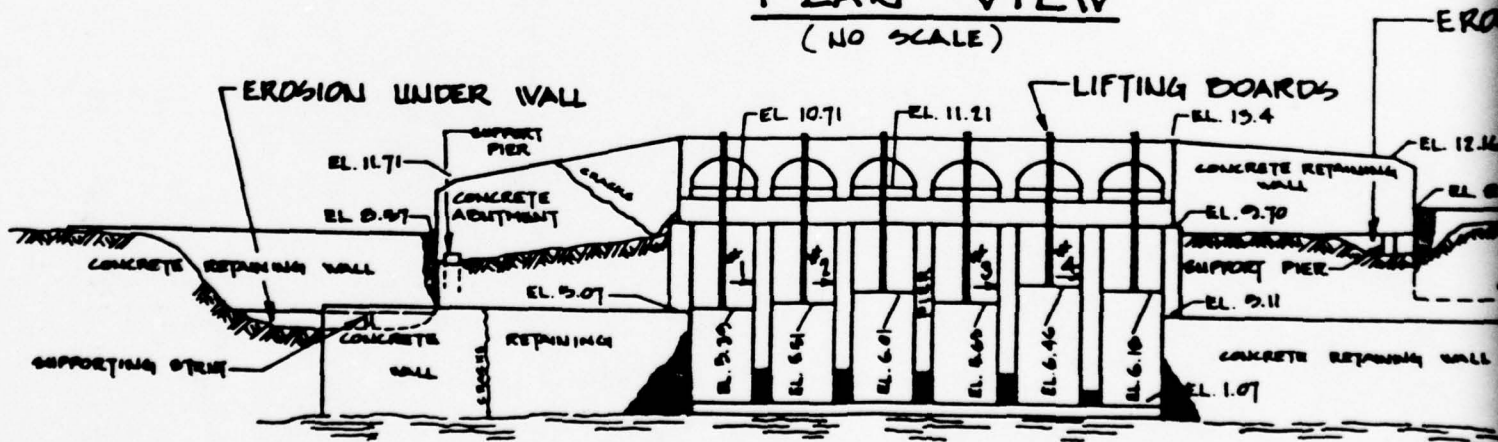
FRONT ELEVATION
(NO SCALE)

Concrete Bridge/Spillway - Severe deterioration at the base of the concrete piers supporting the wooden stop logs forming the spillway was noted. As much as one-third of the concrete section had deteriorated and some of the reinforcing steel was exposed.

■ DENOTES CONCRETE
DETERIORATION

* The concrete piers should be repaired or replaced very soon.
